Manhole Inspection Summary

Manhole # S43MM_004MH

Location Address: **1700 BROADWAY**

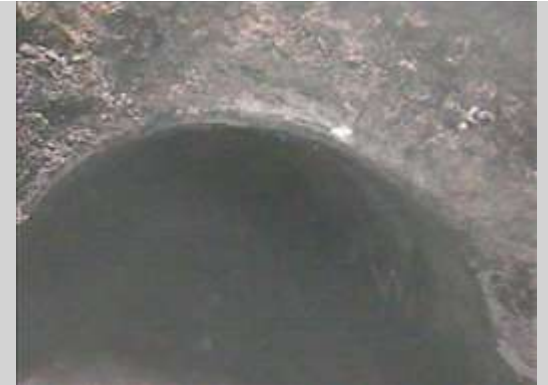
12 O'Clock Outflow

36 in. Circular Gravity Sewer
Pipe Out @ 12 O'Clock

Pipe Height: **32.4** (in.) Rod and Bar
Pipe Material: **Concrete** ☐ Pipe Lined
Invert Depth: **12.60** (ft.) Flow Characteristics: **Fast**
Deposits: ☒ None ☐ Mud ☐ Sludge ☐ Debris ☐ Grease
Silt Depth: (in.) Deposits Extent:
Infiltration: **None** Pipe Seal Cond: **Sound**

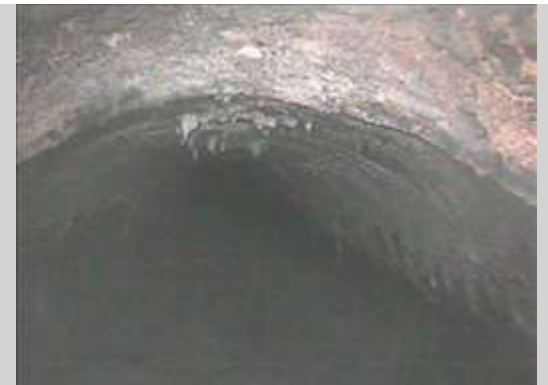
6 O'Clock Inflow

36 in. Circular Gravity Sewer
Pipe In @ 6 O'Clock

Pipe Height: **32.4** (in.) Rod and Bar
Pipe Material: **Concrete** ☐ Pipe Lined
Invert Depth: **12.80** (ft.) Flow Characteristics: **Fast**
Deposits: ☒ None ☐ Mud ☐ Sludge ☐ Debris ☐ Grease
Silt Depth: (in.) Deposits Extent:
Infiltration: **None** Pipe Seal Cond: **Sound**
